AHERA Inspection

Oasis High School 3519 Oasis Boulevard Cape Coral, Florida 33914

Report Number: 23-060217-AS Prepared On: July 6, 2023

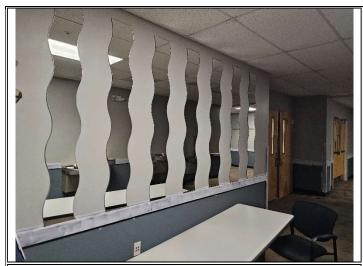
Photo 13: HM-L: Mirror Mastic

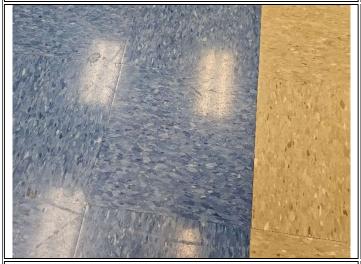
Photo 15: HM-N: 12" x 12" Vinyl Floor Tile, Blue

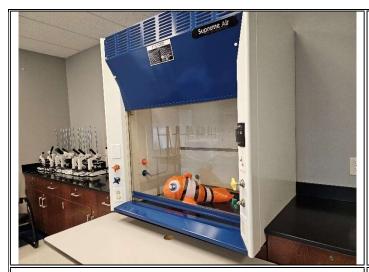
Photo 19: HM-R: Fume Hood, White

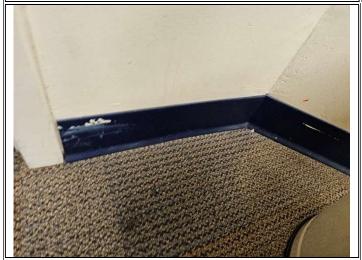
Photo 21: HM-T: Cove Base/Mastic, Navy Blue
