AHERA Inspection

Oasis High School Gymnasium 3519 Oasis Boulevard Cape Coral, Florida 33914

Report Number: 23-060217-AS
Prepared On: July 6, 2023

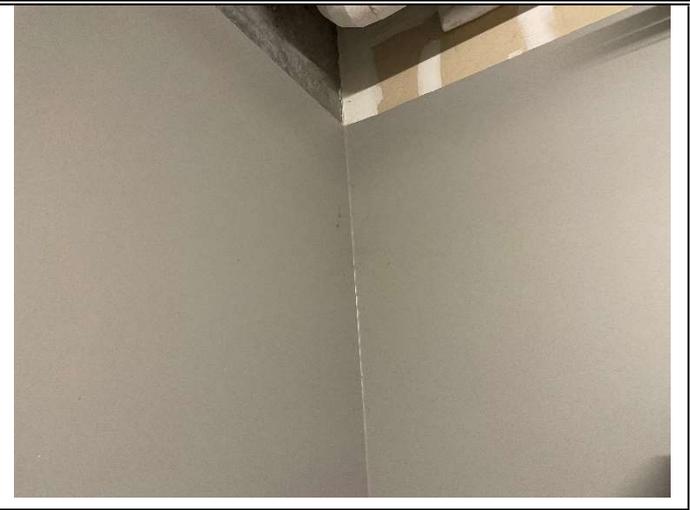
Photo 2: HM-A: Drywall/Joint Compound, White

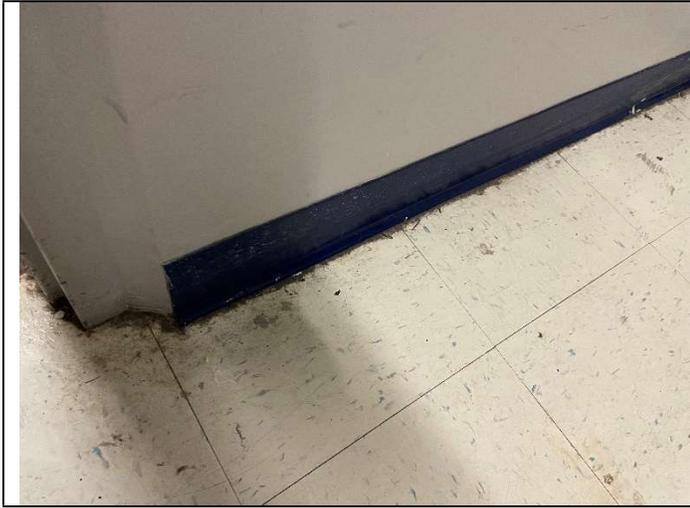
Photo 3: HM-B: Cove Base/Mastic, Navy Blue

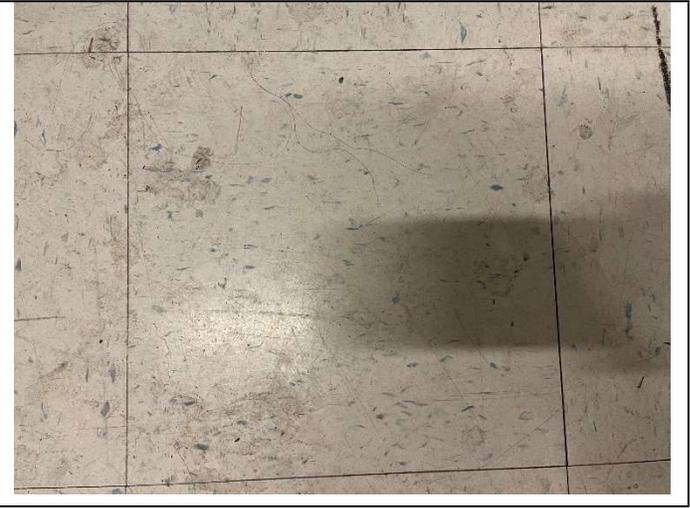
Photo 4: HM-C: 12" x 12" Vinyl Floor Tile, White with Blue Specs

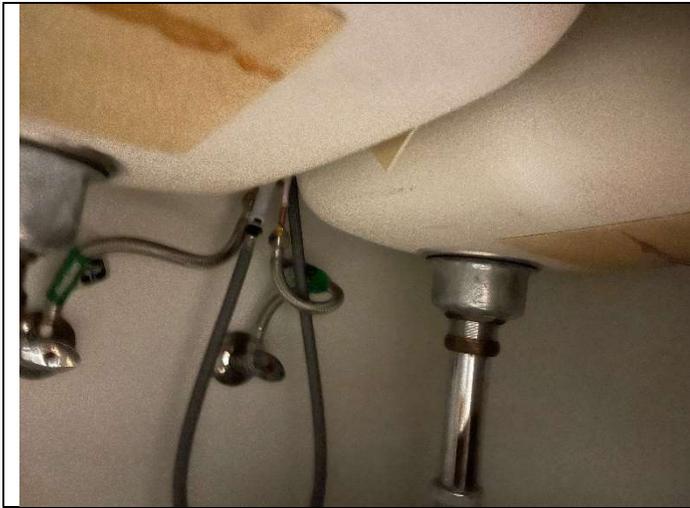
Photo 5: HM-D: Sink Insulation, White

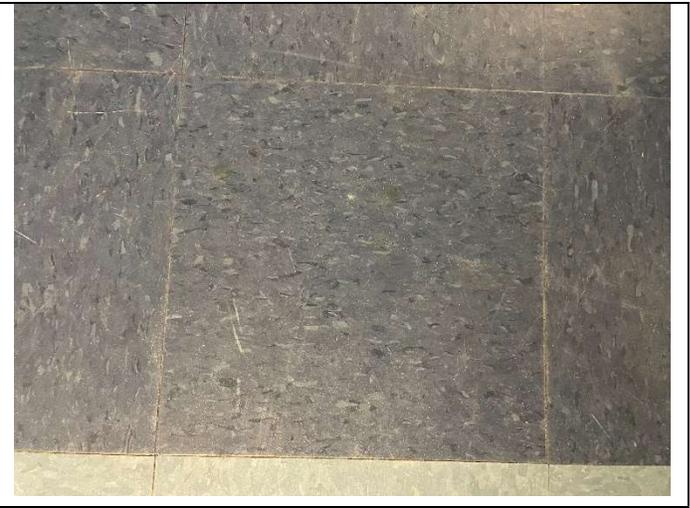
Photo 6: HM-E: 12" x 12" Vinyl Floor Tile, Navy Blue

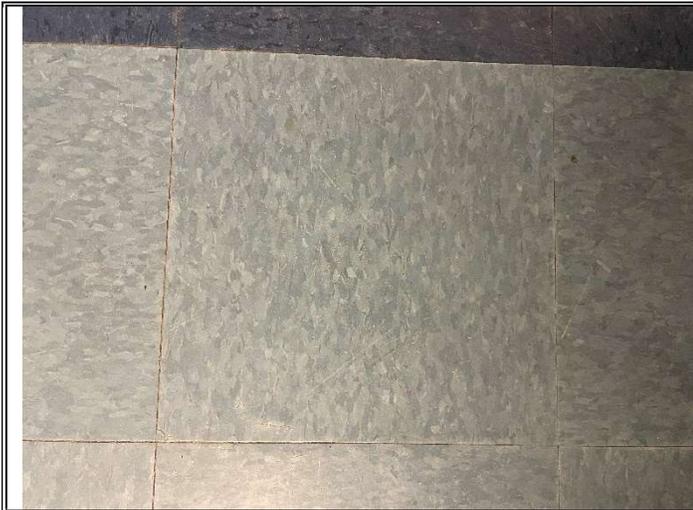
Photo 7: HM-F: 12" x 12" Vinyl Floor Tile, Light Blue

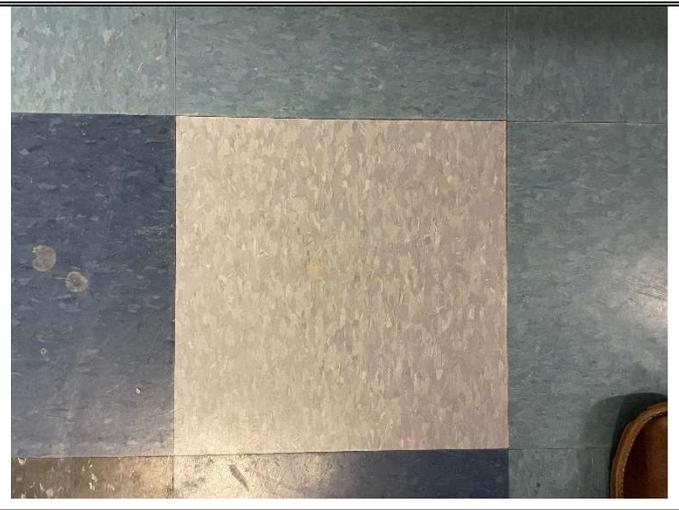
Photo 8: HM-G: 12" x 12" Vinyl Floor Tile, Gray

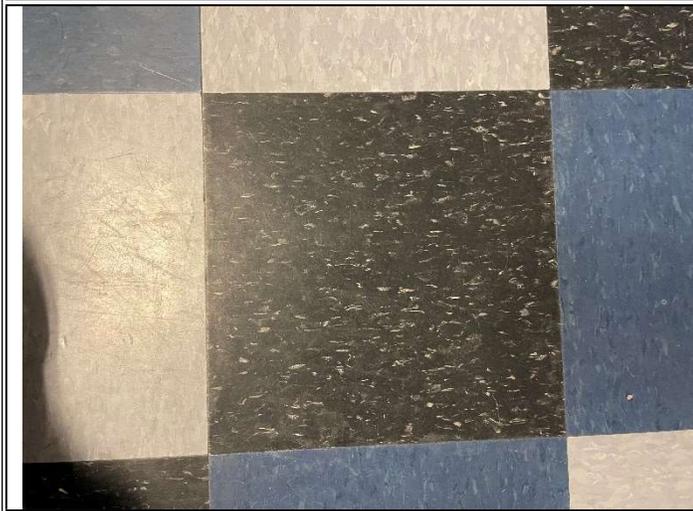
Photo 9: HM-H: 12" x 12" Vinyl Floor Tile, Black

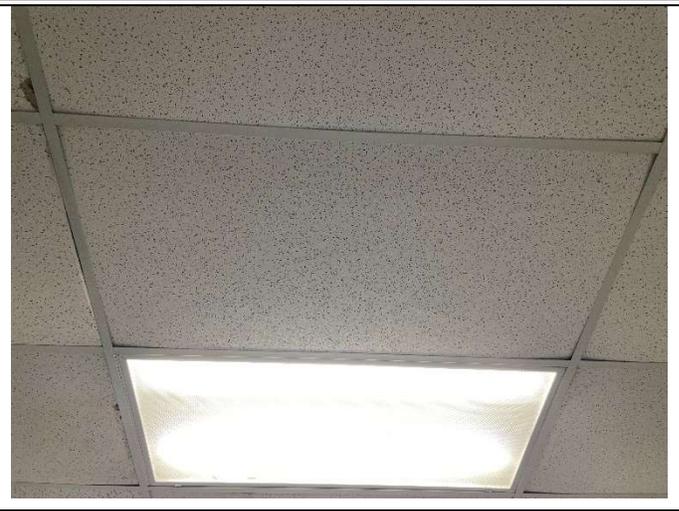
Photo 10: HM-I: 2' x 4' Ceiling Tile, White Pinhole

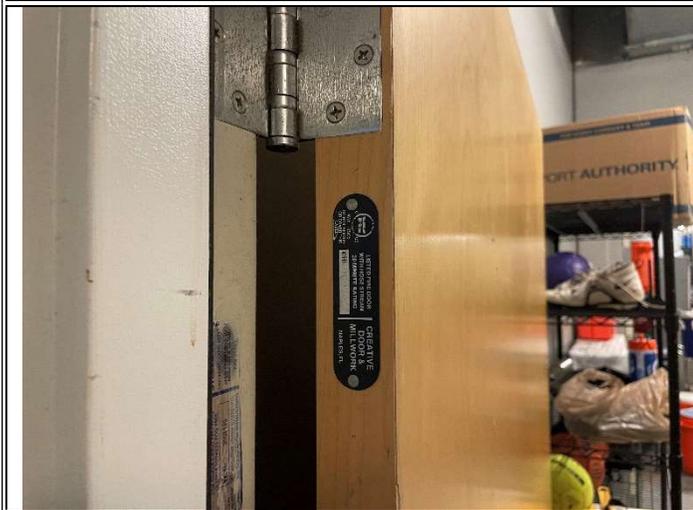
Photo 11: HM-J: Fire-rated Door Insulation, Black Label with Silver Lettering

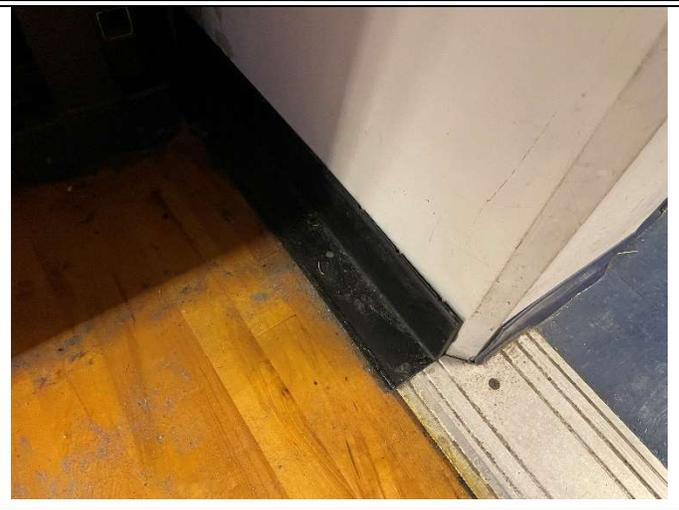
Photo 12: HM-K: Cove Base/Mastic, Black

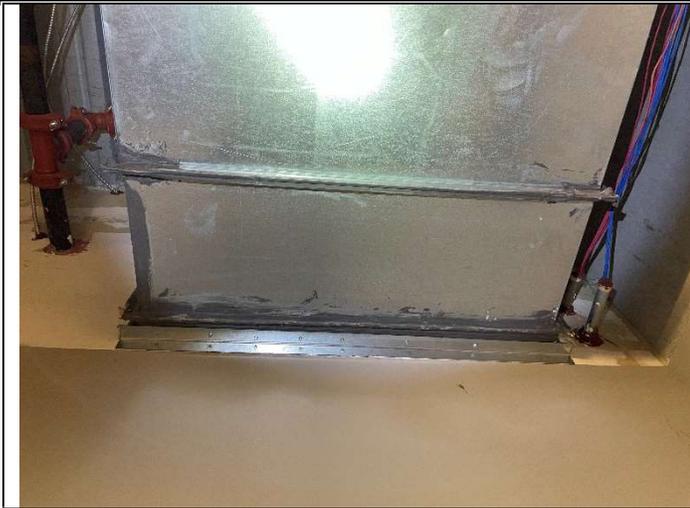
Photo 13: HM-L: Duct Mastic, Gray

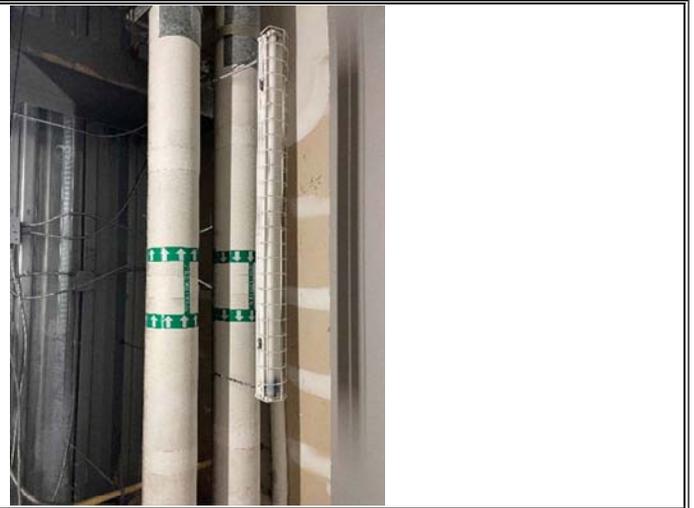
Photo 14: HM-M: Pipe Run Wrap, White

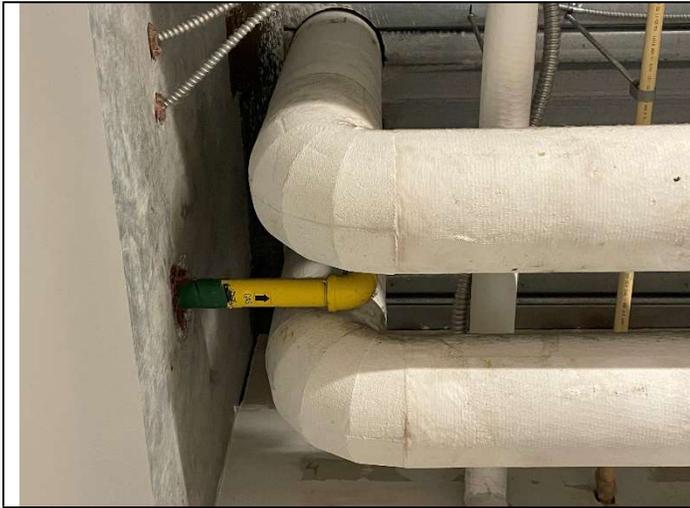
Photo 15: HM-N: Pipe Elbow Wrap, White

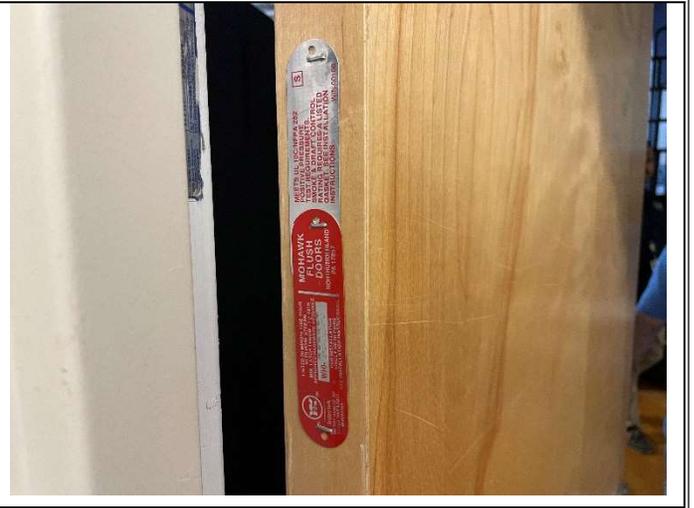
Photo 16: HM-O: Fire-rated Door Insulation, Red Label with Silver Lettering

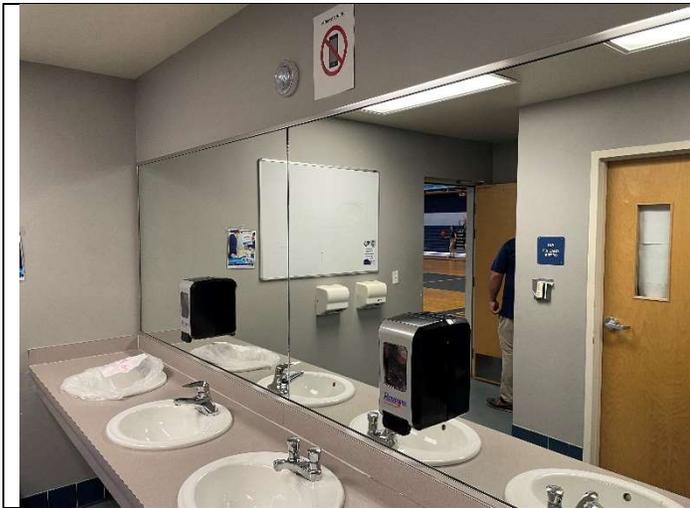
Photo 17: HM-P: Mirror Mastic

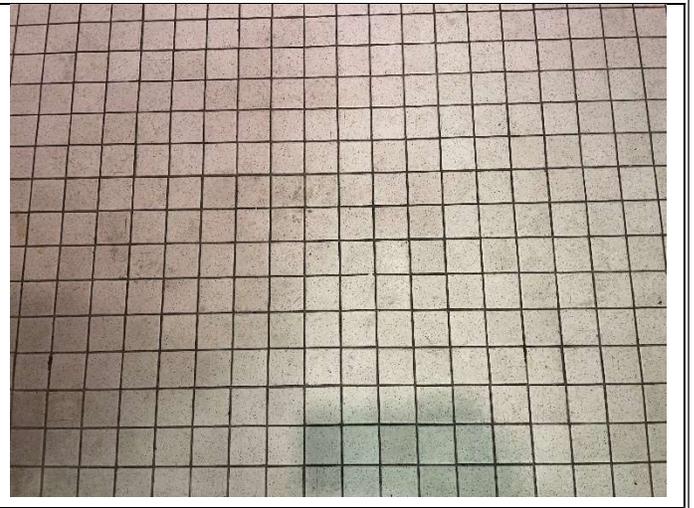
Photo 18: HM-Q: 2" Ceramic Tile, White

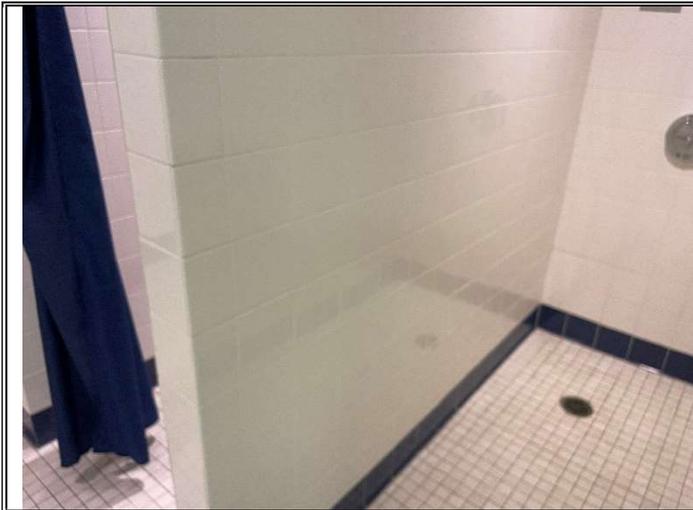
Photo 19: HM-R: 6" Ceramic Wall Tile, White

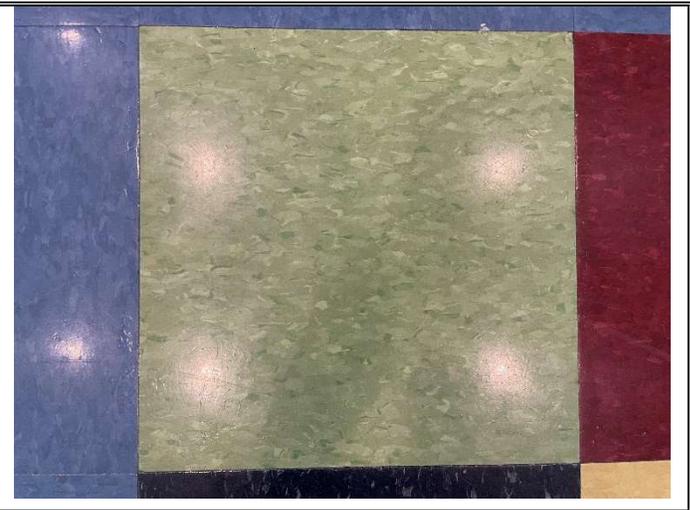
Photo 20: HM-S: 12" x 12" Vinyl Floor Tile, Green

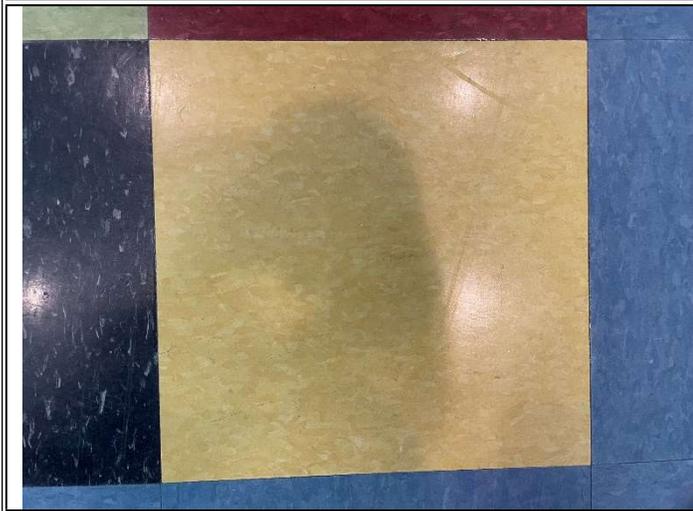
Photo 21: HM-T: 12" x 12" Vinyl Floor Tile, Orange

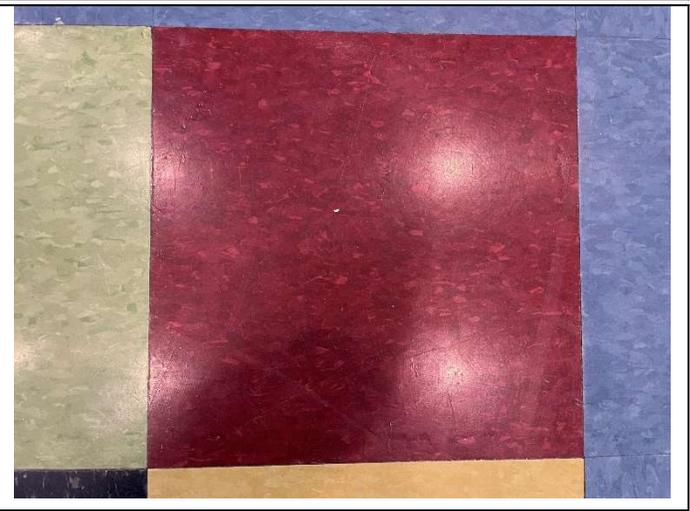
Photo 22: HM-U: 12" x 12" Vinyl Floor Tile, Red

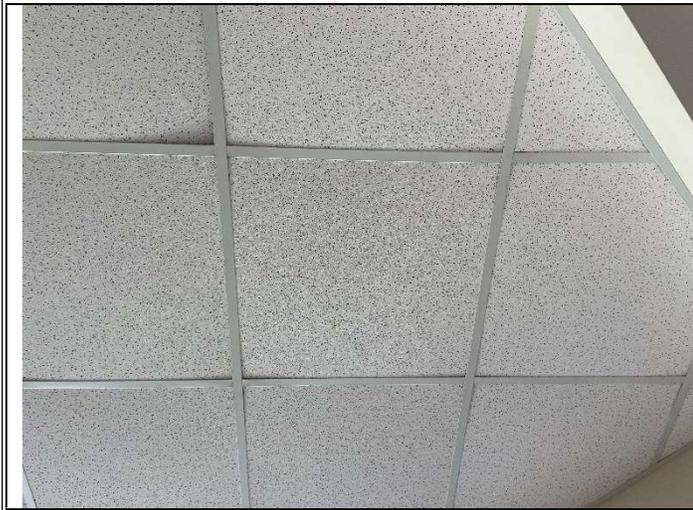
Photo 23: HM-V: 2' x 2' Ceiling Tile, White Pinhole

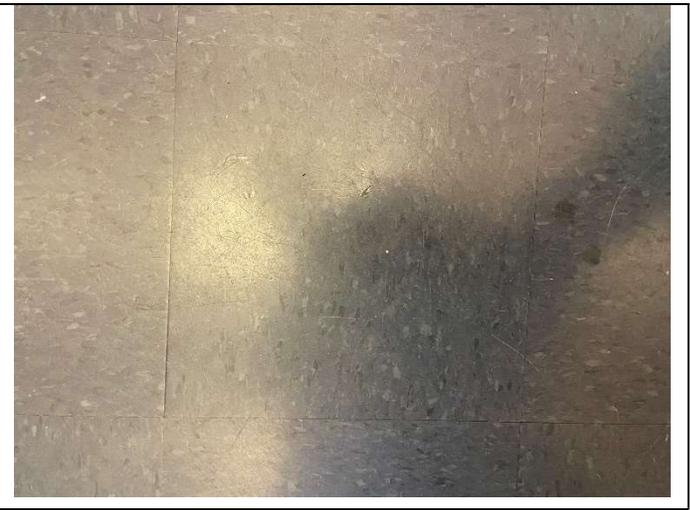
Photo 24: HM-W: 12" x 12" Vinyl Floor Tile, Navy Blue with Light Blue Specs

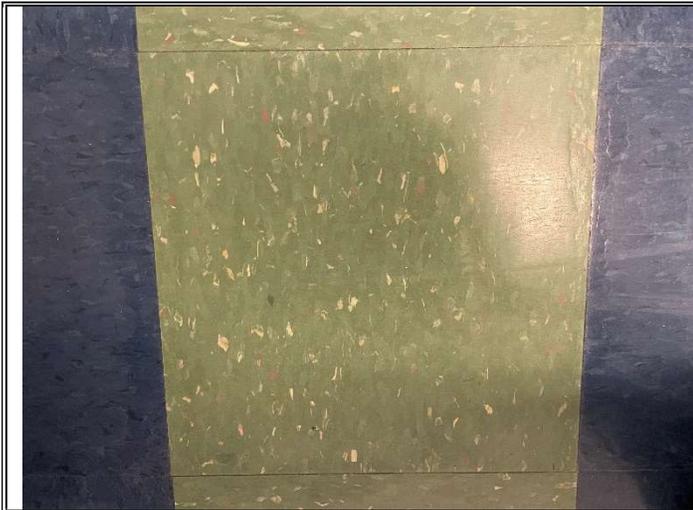
Photo 25: HM-X: 12" x 12" Vinyl Floor Tile, Green with Tan Specs

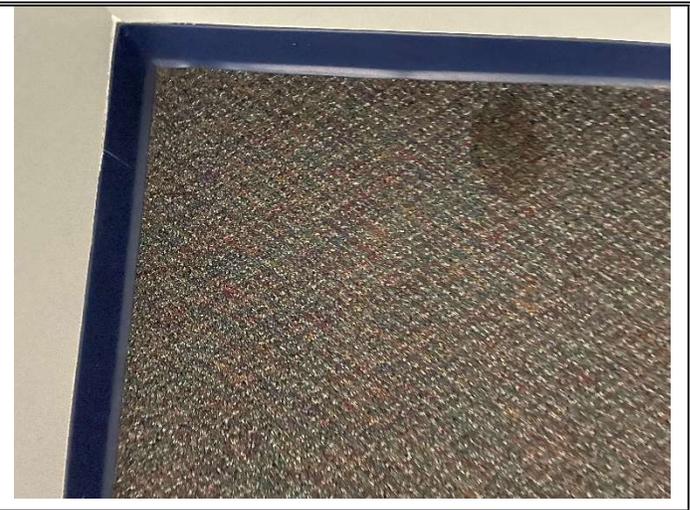
Photo 26: HM-Y: Carpet Mastic, Yellow

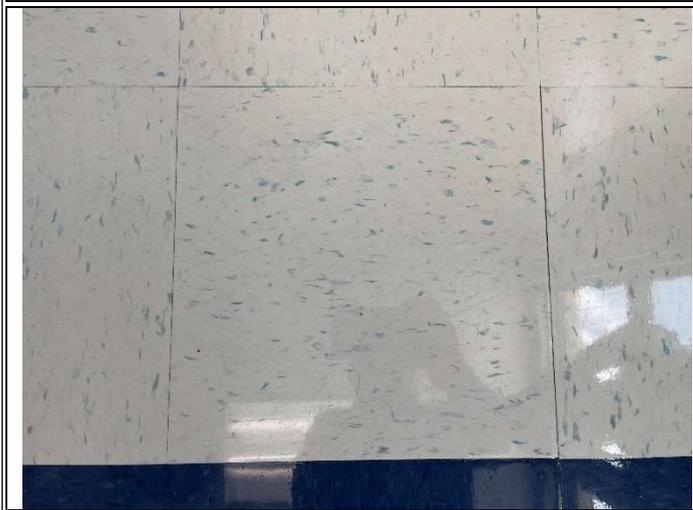
Photo 27: HM-Z: 12" x 12" Vinyl Floor Tile, White with Blue Specs
